ER 2742  
DESIGN AND DEVELOPMENT  
OF A MAJOR ENGINE COMPONENT (COMPRESSOR)  
FOR A GERM TURBINE GENERATOR SET

FINAL REPORT

By  
Robert L. Giddens  
&  
Douglas J. Martin

to  
US ARMY MOBILE EQUIPMENT RESEARCH AND  
DEVELOPMENT COMMAND  
ELECTRICAL POWER LABORATORY  
FT. BELVOIR, VA 22060  
Report Under Contract No. DMRD 77-2-0399

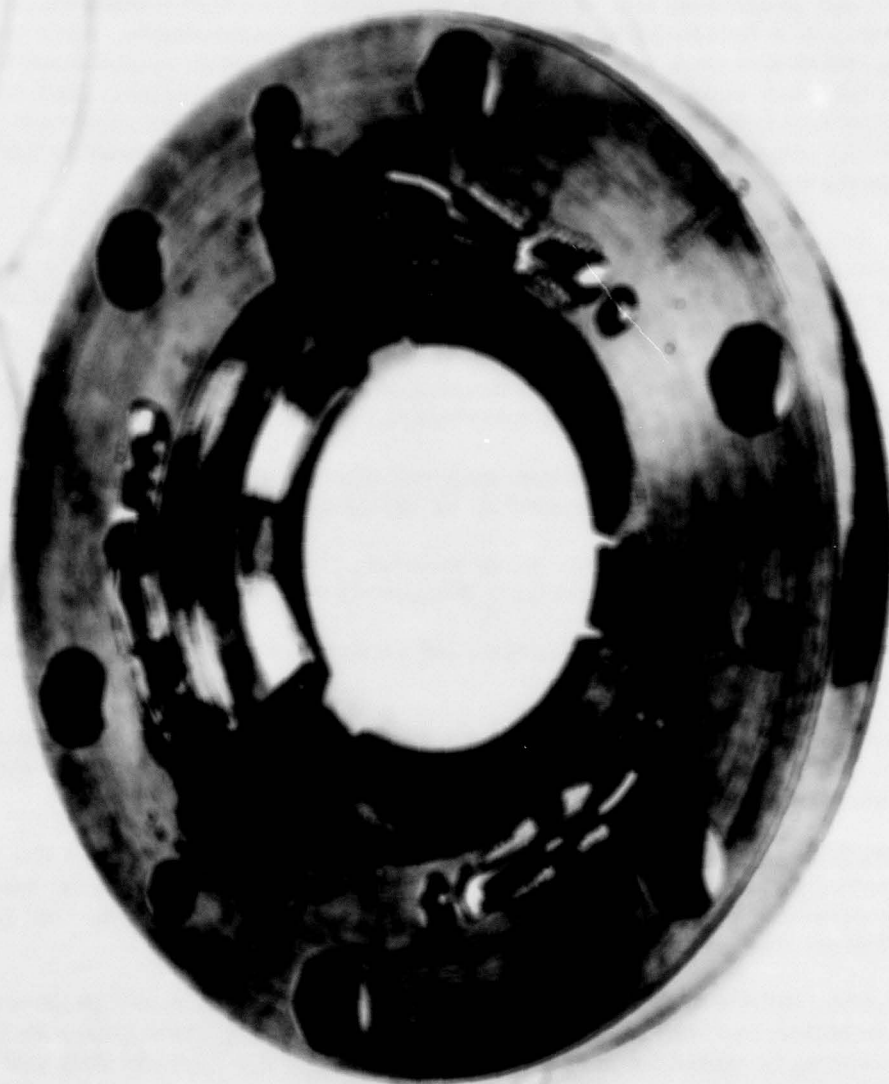
Figure 31. Bearing Thrust Monitoring Device

During the early phase of the test program, the rig was modified to incorporate a strain gage, thrust-measuring device to evaluate rotor end thrust during rig operation. Figure 31 shows the strain-gage bearing retainer plate that was used to measure the axial load on the thrust bearing. The gages are in a two-gage bridge

to provide temperature compensation and are epoxy-encanted into position on three flexible tabs which support the bearing outer race. These tabs have a spring rate of approximately 750,000 lb/in. The tabs were spring-loaded to allow measurement of thrust loads in the range of -50 to +300 pounds. The thrust bearing is spring-loaded against a retainer plate by three ball-bearing washers acting against a floating bushing between the bearing and housing.

The transducer gages were replaced and bonded with a high performance adhesive called M-bond 61A, which is formulated specifically for bonding transducer strain gages in applications up to 450°F. Prior to assembly in the engine test rig, the strain gage circuits were checked in a laboratory oven for temperature compensation up to 300°F. Also incorporated into the current build of the engine test rig was an increase in the bearing thrust preload from 50 to 100 pounds. This allowed negative bearing thrust to be measured up to 100 pounds. On the third mechanical checkout run, the bearing thrust-measuring device, which was now operating satisfactorily, indicated a negative thrust (toward engine exhaust) of 30 to 35 pounds while the engine test rig was operating at approximately 70 percent speed. The rotor thrust measuring device indicated 65 pounds negative while operating at approximately 98.5 percent speed.

During the initial mechanical check runs, bearing thrust load instrumentation was not working correctly and further problems were experienced with the epoxy adhesive, which was found to be unsuitable for this application.

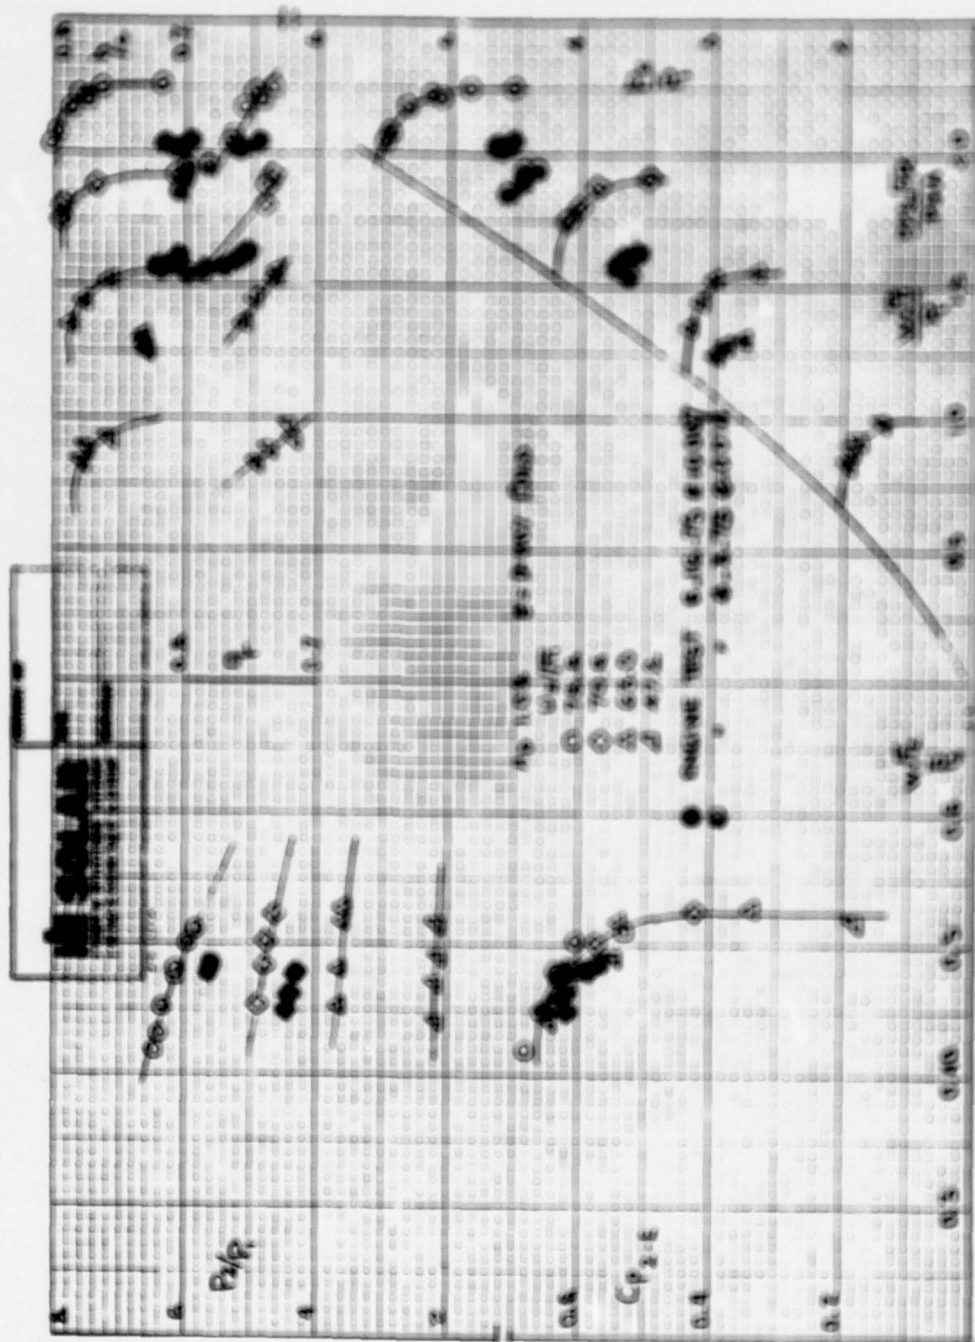
Figure 36. Compressor Performance (0.024-inch Shroud Clearance)

Impeller axial clearance was therefore reduced to 0.014 inch on the next performance calibration on 6-3-75. The peak pressure ratio increased slightly to 4.6, see Figure 36. Examination of the compressor on subsequent shutdown revealed that the abrasible shroud coating had not been touched; thus, it was decided to re-shim to further reduce the axial clearance to the design setting of 0.007 inch and return the engine test rig for calibration. Subsequent compressor performance (obtained 6-16-75) showed that at design speed peak pressure and efficiency had increased to 4.7 and 72 percent respectively with a 13 percent increase in airflow. The results of this test are also shown on Figure 36.
